Floods in May 2014 in the Sava River Basin

Brief overview of key events
and lessons learned

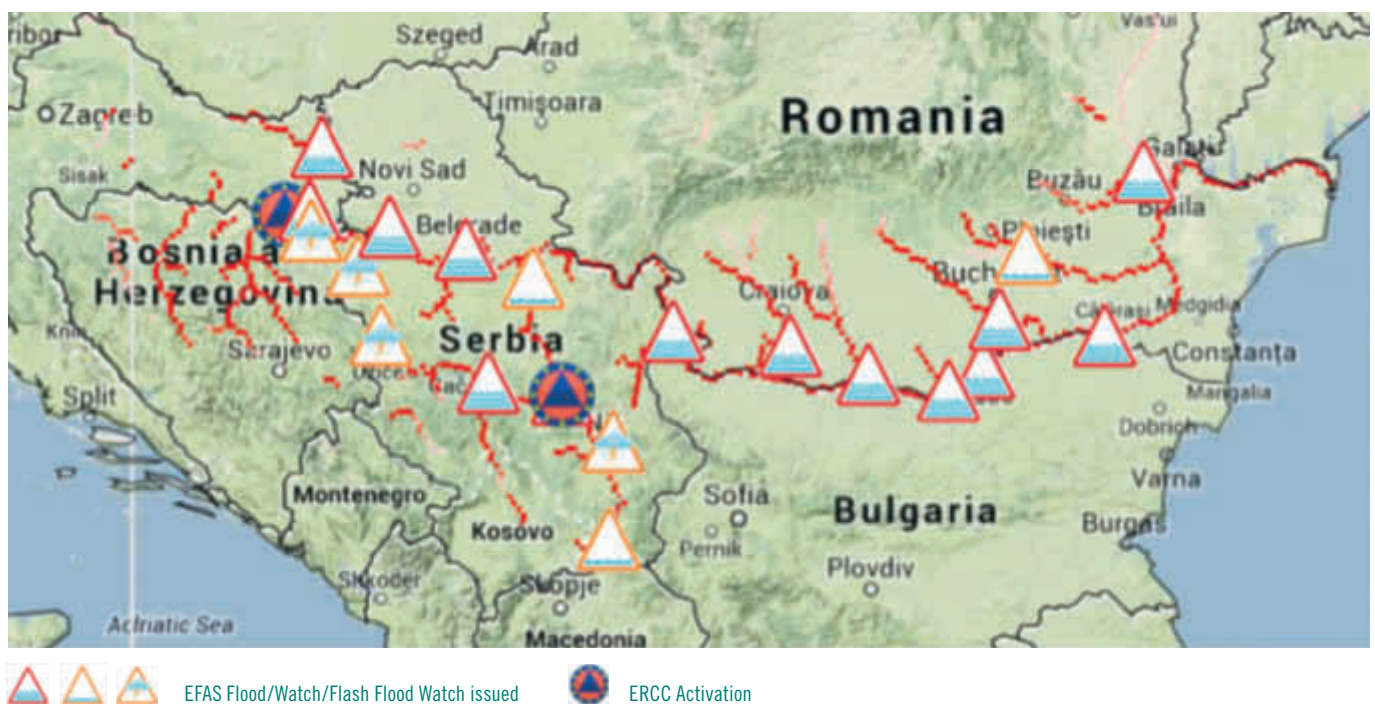
FIGURE 4

Overview active EFAS warnings for 2014-05-15 12UTC forecast (source: EFAS)

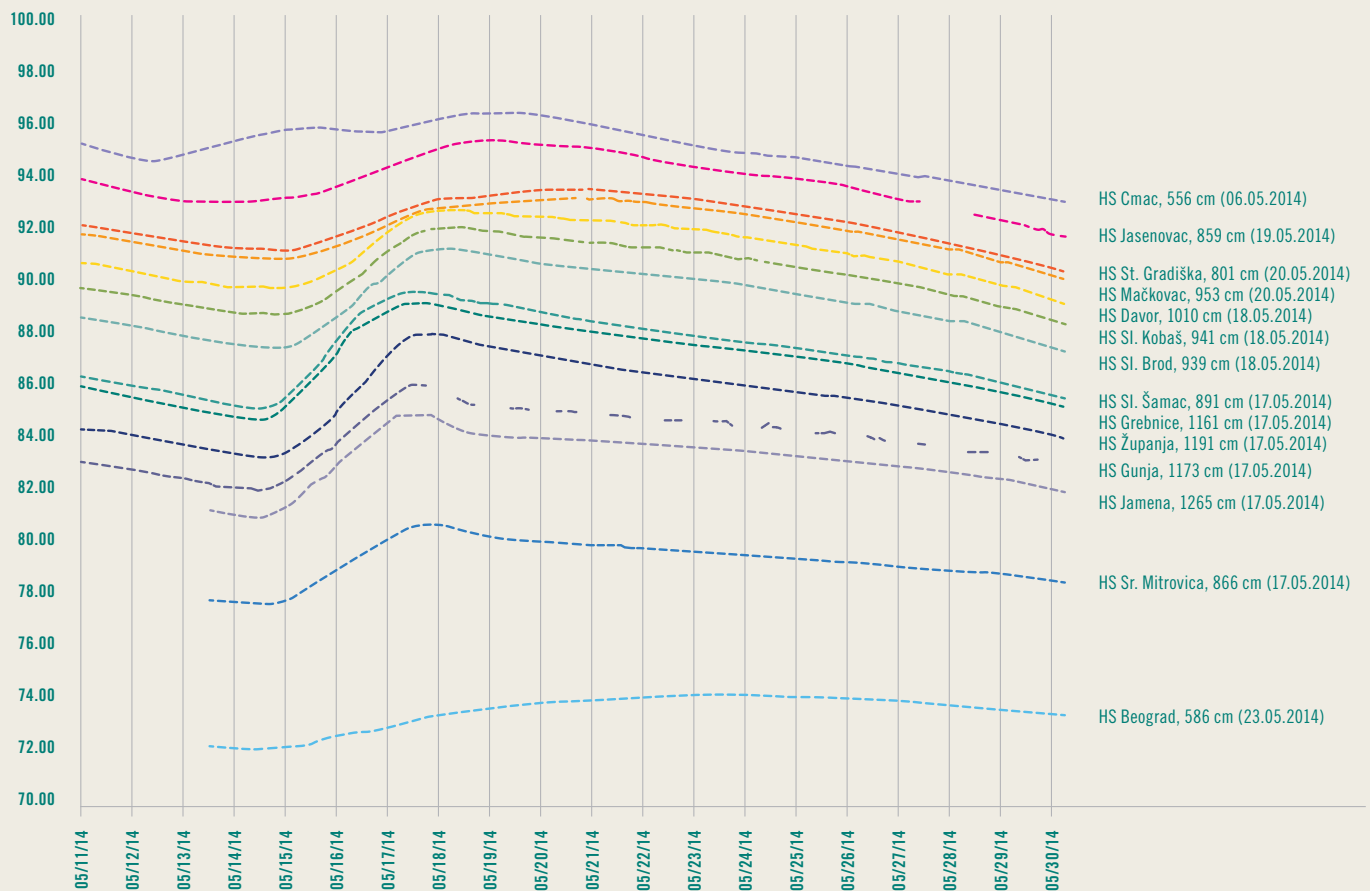
FIGURE 5

Comparison of water levels at selected hydrological stations along the Sava River

DHMZ and RHMZS carried out several hydrometric measurements on the Sava River during the May 2014 flood event. Measured water levels, flow velocities and flow rates were higher than ever before.

DHMZ measured 6,008 m³/s at Slavonski Šamac at water level of 889 cm. Based on the hydrological analysis it was concluded that this discharge had a return period of 1000 years.

RHMZS estimated that peak of the Sava flood wave downstream of the Drina river mouth (recorded on 17th May at Sremska Mitrovica) was 6,600 m³/s, and had return period of 100 years. It should be noted that the flood peak was reduced because the dikes on the left bank (Croatia) and the right bank of the Sava River (B&H) breached on several locations, and large areas were flooded.

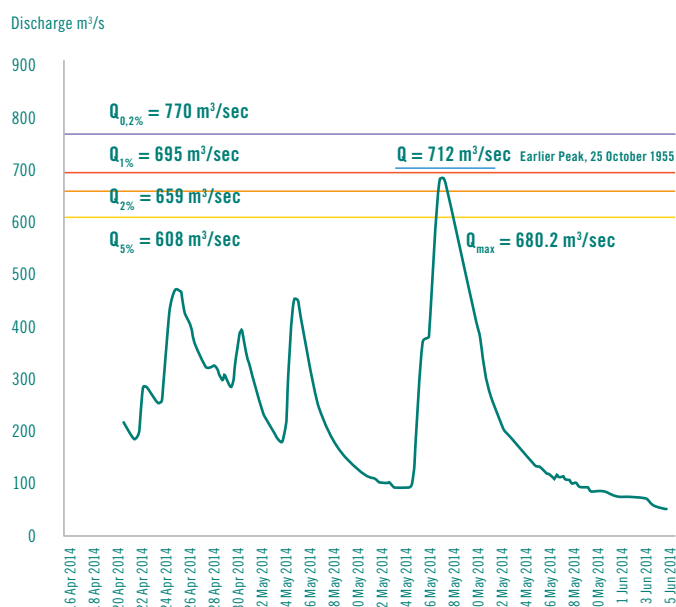
FIGURE 6

Hydrograph of the Sana River in April– May 2014, at hydrological station Sanski Most

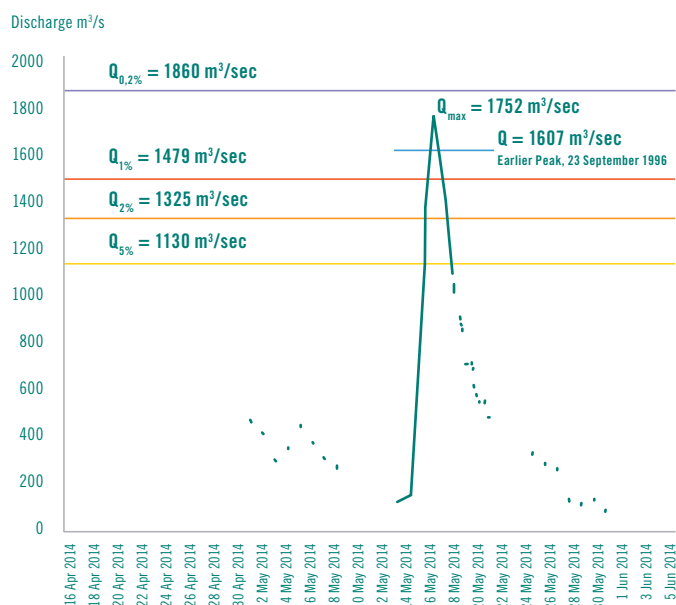
FIGURE 7

Hydrograph of the Vrbas River in April– May 2014, at hydrological station Delibašino Selo

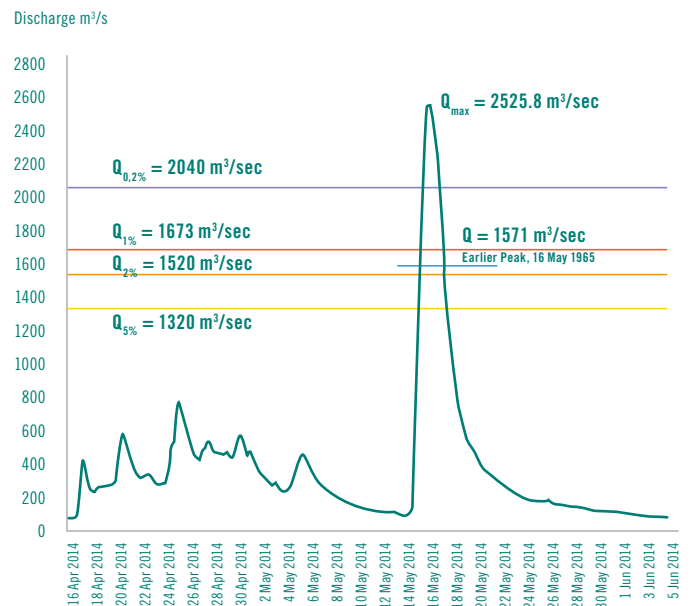
FIGURE 8

Hydrograph of the Bosna River in April–May 2014, at hydrological station Zavidovići (middle course)

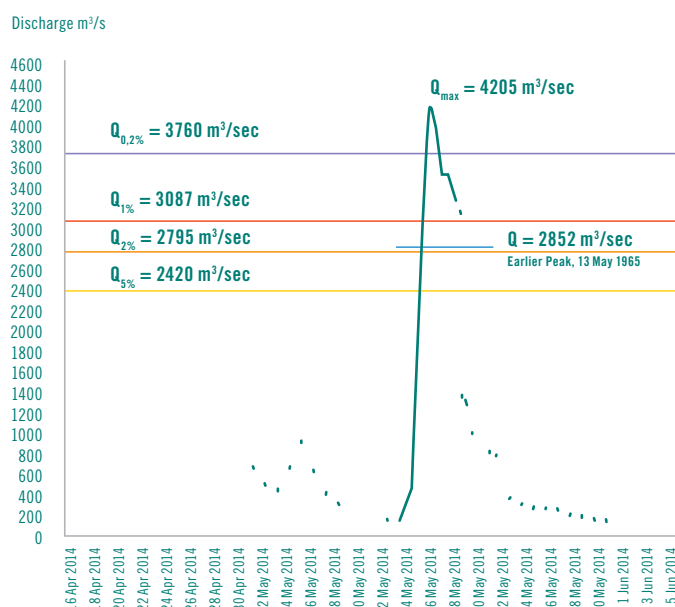
FIGURE 10

Hydrograph of the Bosna River in April–May 2014, at hydrological station Doboj (lower course)

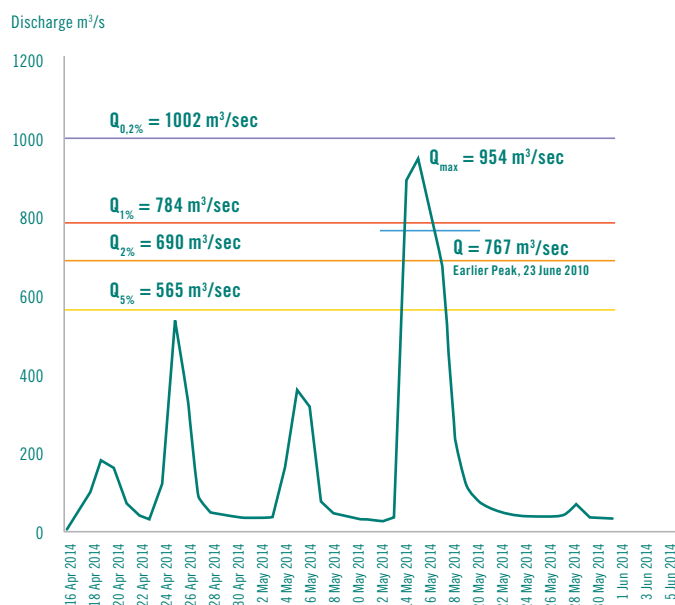
FIGURE 11

Hydrograph of the Kolubara River in April–May 2014, at hydrologic station Beli Brod (middle course)

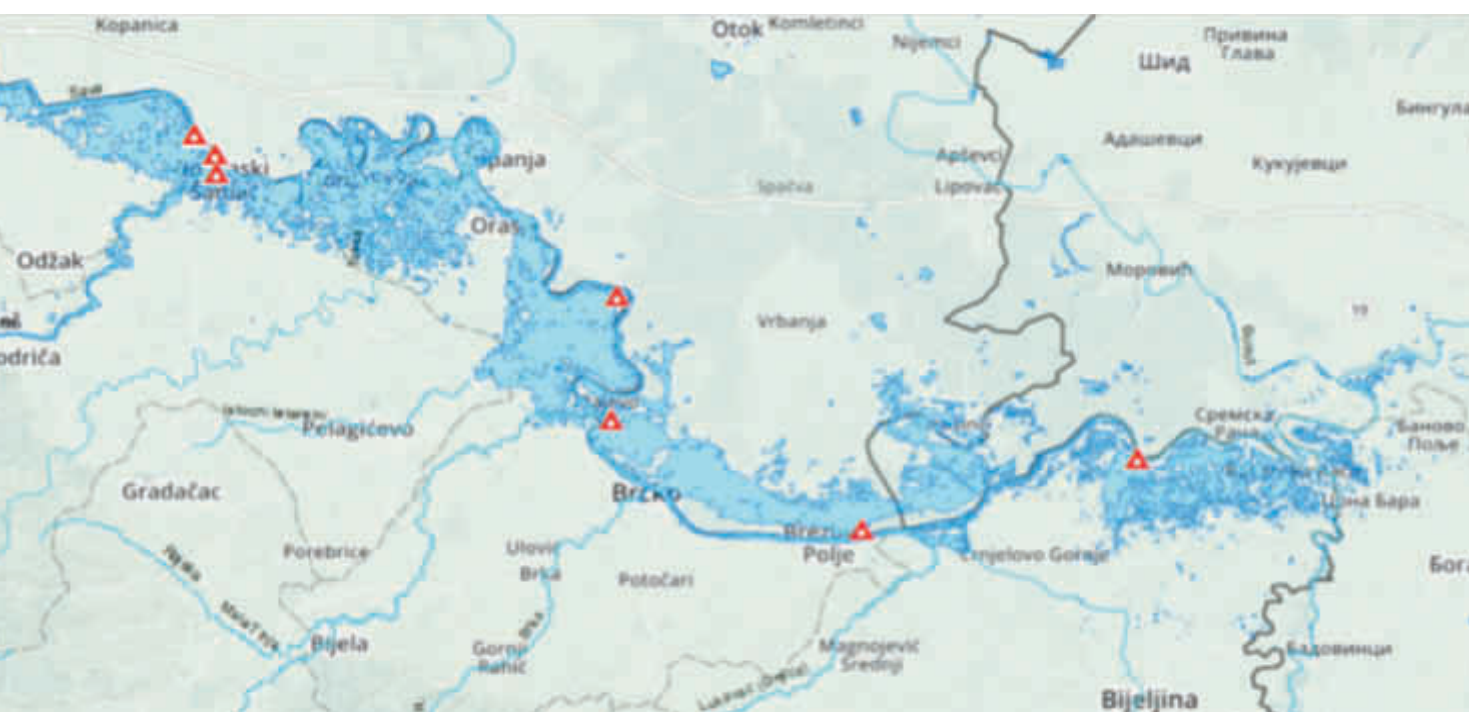
FIGURE 12

Flooded areas and locations of dike breaches along the Sava River

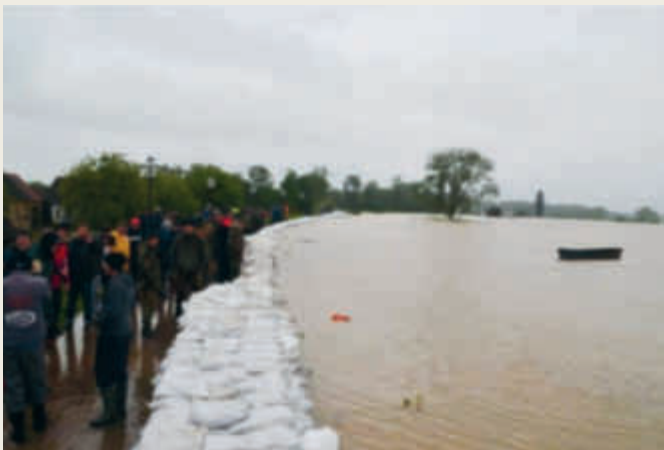
FIGURE 13

Emergency defence in Županja, Croatia

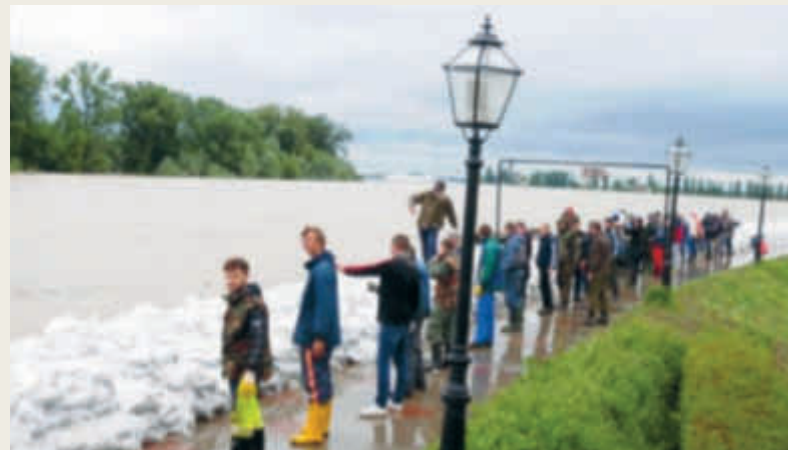
FIGURE 14

Emergency defence in Gunja, Croatia

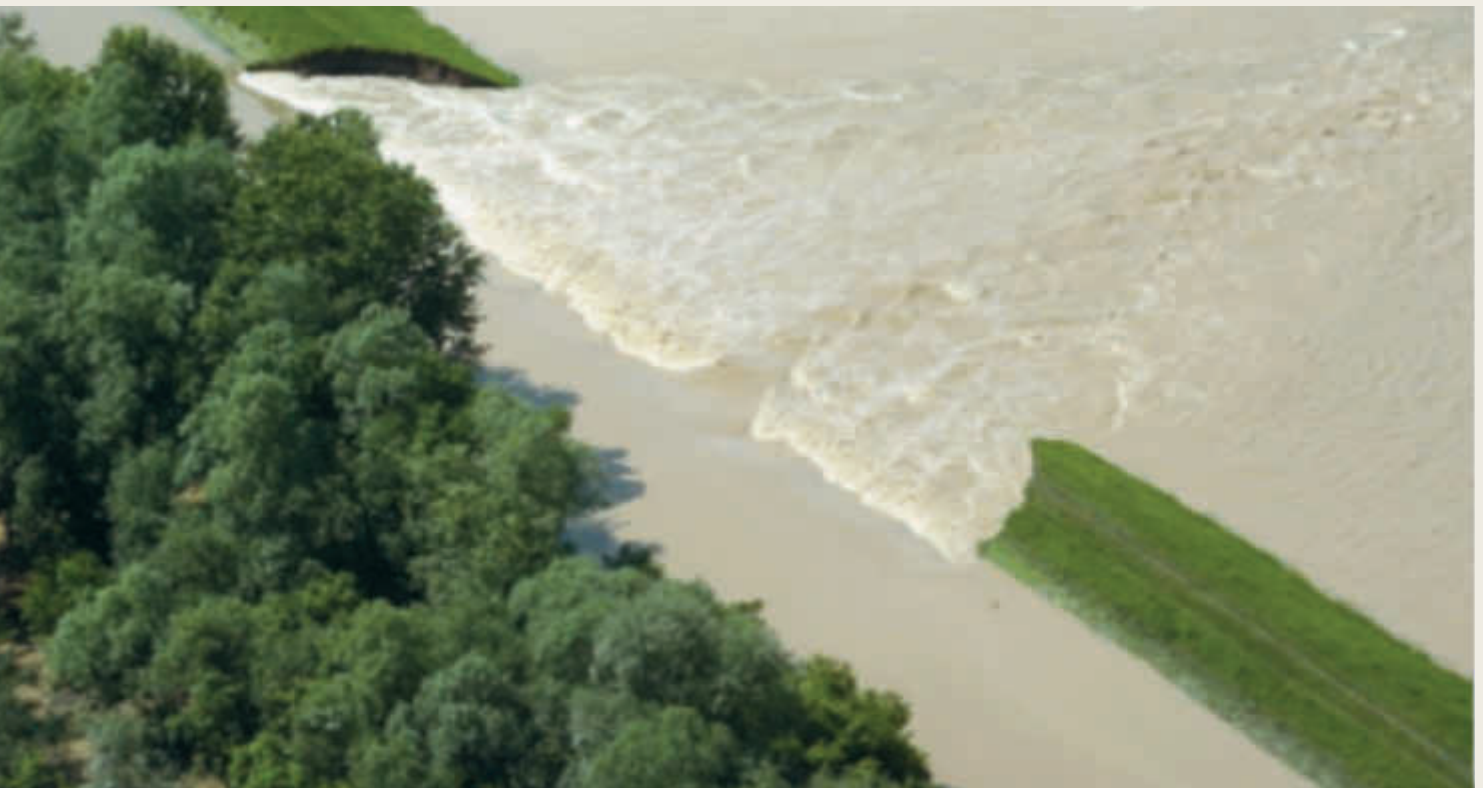
FIGURE 15

Dike breach near Rajevo Selo, Croatia

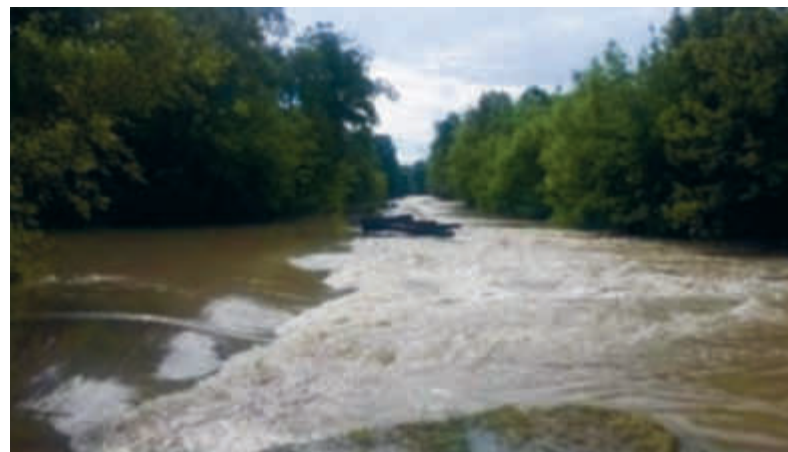
FIGURE 19

In Odžačka Posavina, which is the area upstream of the Bosna River mouth into the Sava River, coincidence of high flows of the Sava and Bosna rivers caused dike overtopping and breaches. Dike overtopping, both on the right and left bank, occurred firstly closely upstream of the Bosna River mouth, where the river suddenly narrows from 2.5 km to 0.75 km. On 17th and 18th May high waters of the Sava River caused dike breaches on 6 locations (total length 460m).

Dike overflow in Prud, B&H

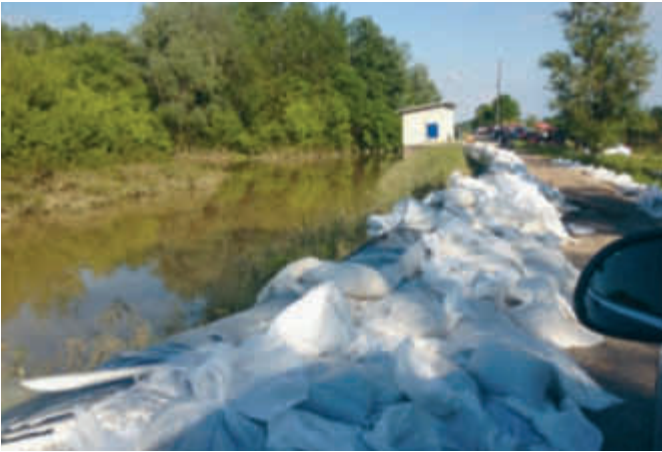
FIGURE 20

Emergency measures in Prud, B&H

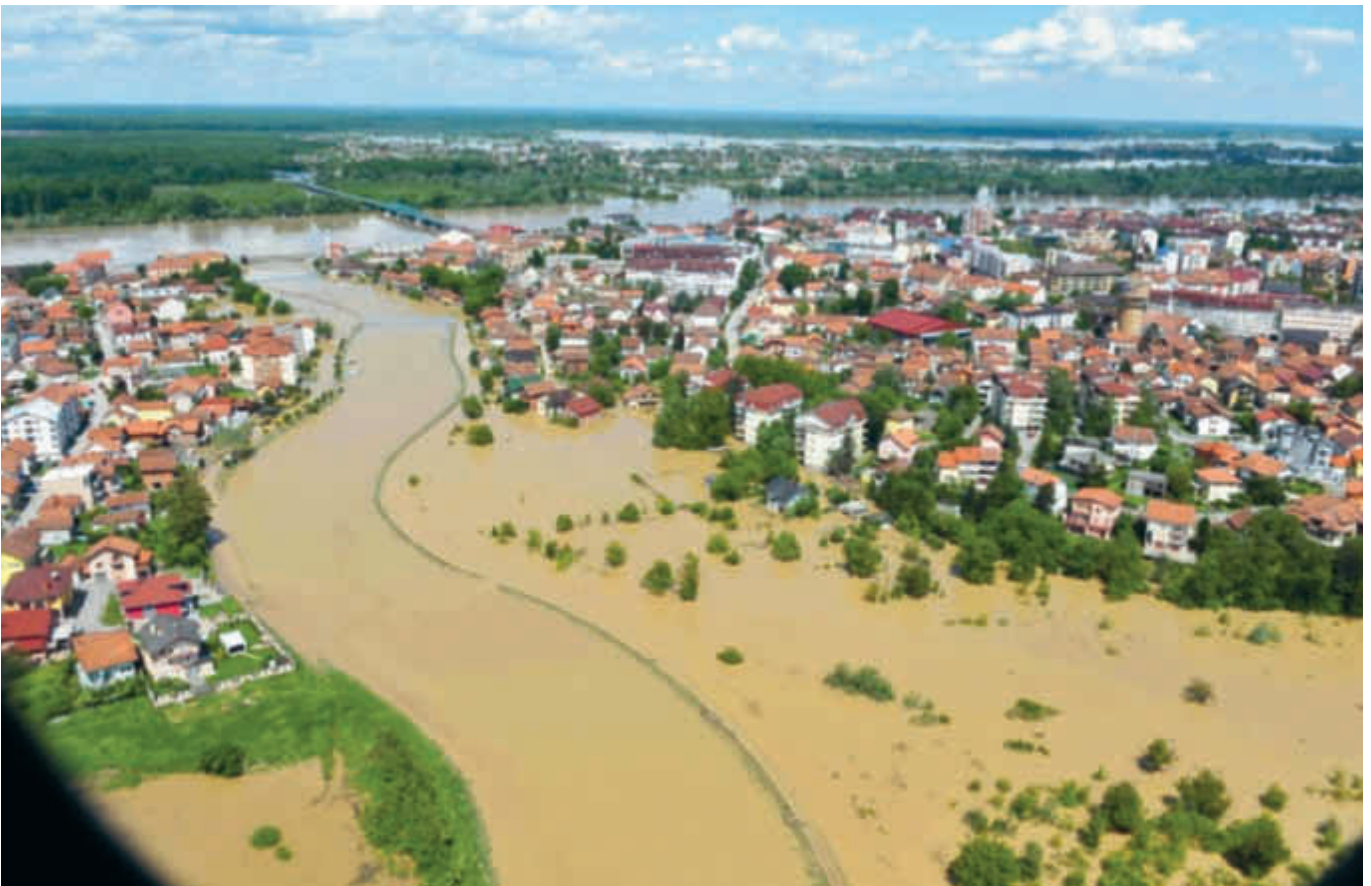
FIGURE 21

The Sava dike breach on the section Kapanice contributed to flooding of Srednja Posavina region (downstream from the Bosna river mouth), in addition to flooding by the Bosna River. The 80m long dike breach was in the sharp bend of the Sava River, where the flood channel narrows from 3 to 1 km. The flood spread downstream from Orašje towards the Brčko town.

Flooded town of Brčko, B&H

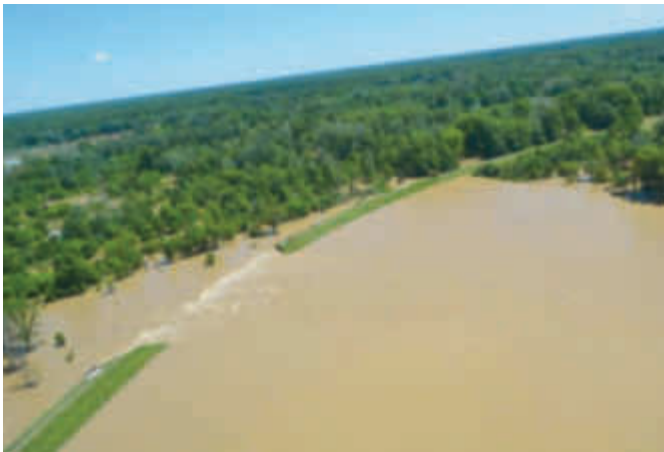
FIGURE 22

Dike breach in Kopanice, B&H

Evacuation of flood waters from Odžačka and Srednja Posavina started after the Sava water level dropped down. Pumping stations had to be rehabilitated after flood damage, outlets opened, additional mobile pumps included, and dike breaches deepened, in order to evacuate the remaining water from the flooded area as soon as possible. Rehabilitation of dikes and closing of breaches started on 5th June, and was completed in 40 days.

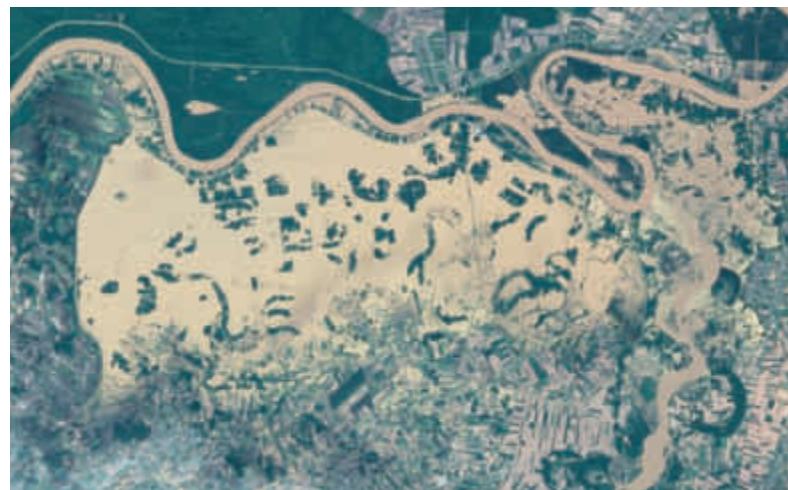
FIGURE 24

**Flooded area at the Drina River mouth, on 19th May 2014**

On 14 May 2014 the Drina River overflowed its banks downstream of Janja and flooded settlements in the Bijeljina area, including the entire industrial area (Fig 24).

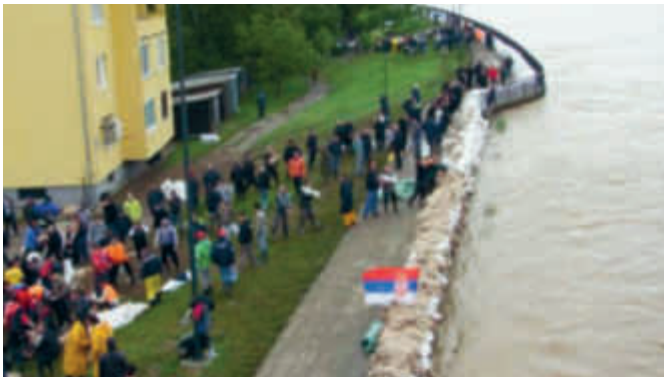
FIGURE 25

Emergency measures along Sremska Mitrovica quay, Serbia

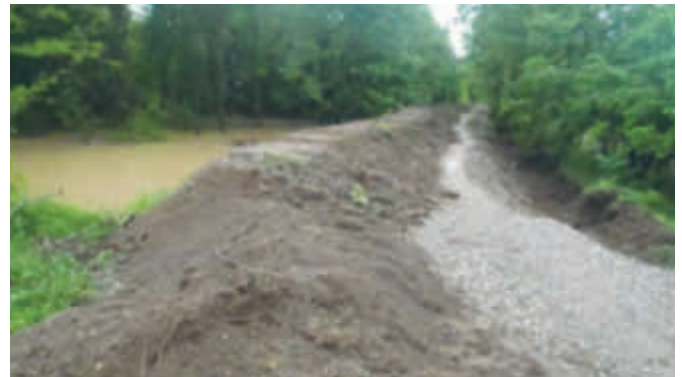
FIGURE 26

Emergency dike on the top of right Drina River dike, Serbia

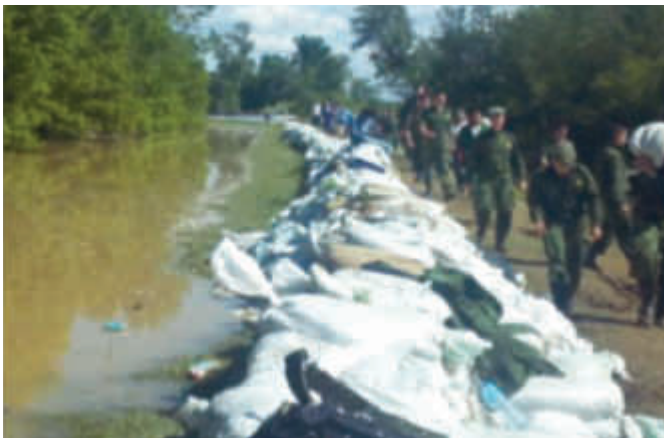
FIGURE 27

Emergency measures along a low part of the dike upstream of Šabac, Serbia

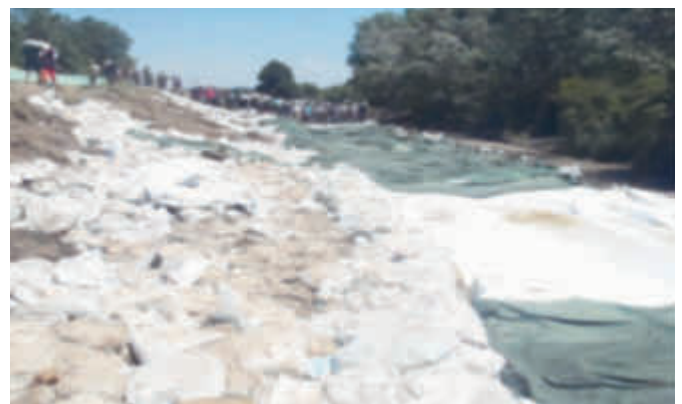
FIGURE 28

Emergency measures along a part of the dike where reconstruction was ongoing, upstream of Šabac, Serbia

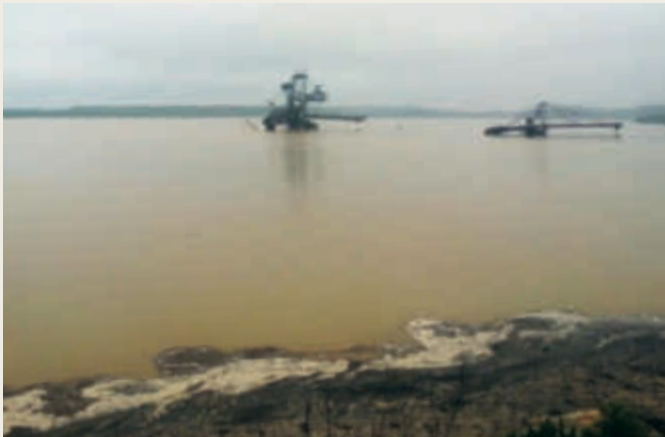
FIGURE 34

**Flooded open pit coal mine “Tamnava – West Field”,
Serbia**

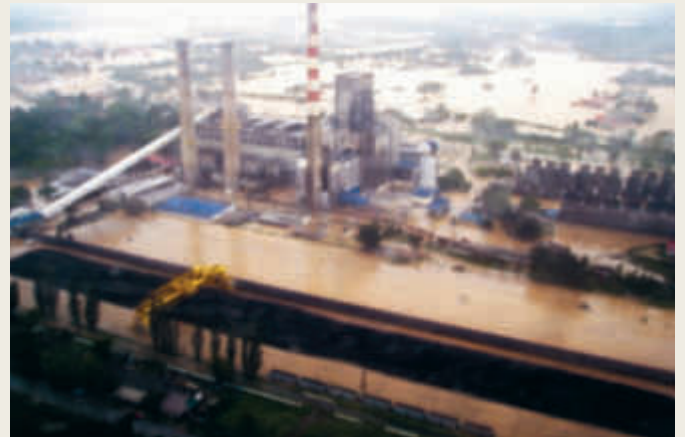
FIGURE 35

Namely, some residential areas are situated on very low-lying land – abandoned branches of the Sava and the Kolubara, from which flood water had to be pumped. Serbian main electrical power production facility – TPP Nikola Tesla was also endangered.

**TPP Nikola Tesla surrounded by flood,
Serbia**
